## TECHNICAL SERVICE BULLETIN

### Torque-On-Demand (TOD) Transfer Case - Grinding/Clicking/Ratcheting Noise From Front Wheel Area

**20-2307**15 October  
2020**Model:**

<b>Ford</b> 2003-2020 Expedition
2006-2020 F-150
<b>Lincoln</b> 2003-2020 Navigator

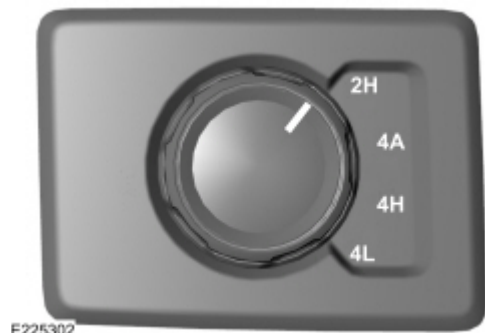
Figure 1 - Example of MSS with 4A selection

1. Does the vehicle have a mode select switch (MSS) that includes a 4-wheel auto (4A) option?  
(Figure 1)
  - (1). Yes - proceed to Step 2.
  - (2). No - this article does not apply. Refer to the Workshop Manual (WSM) for normal diagnostics.

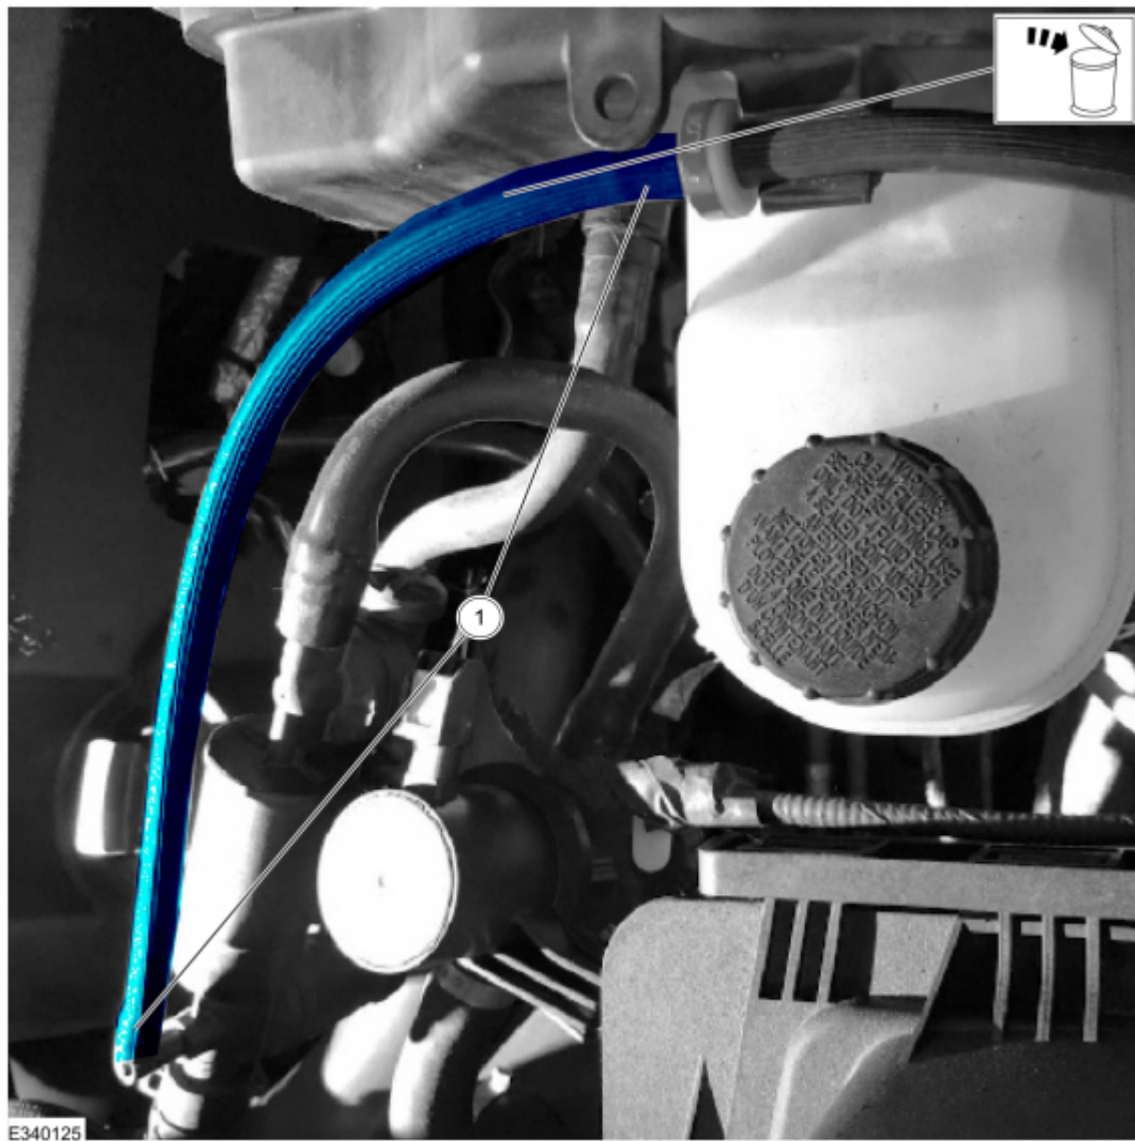
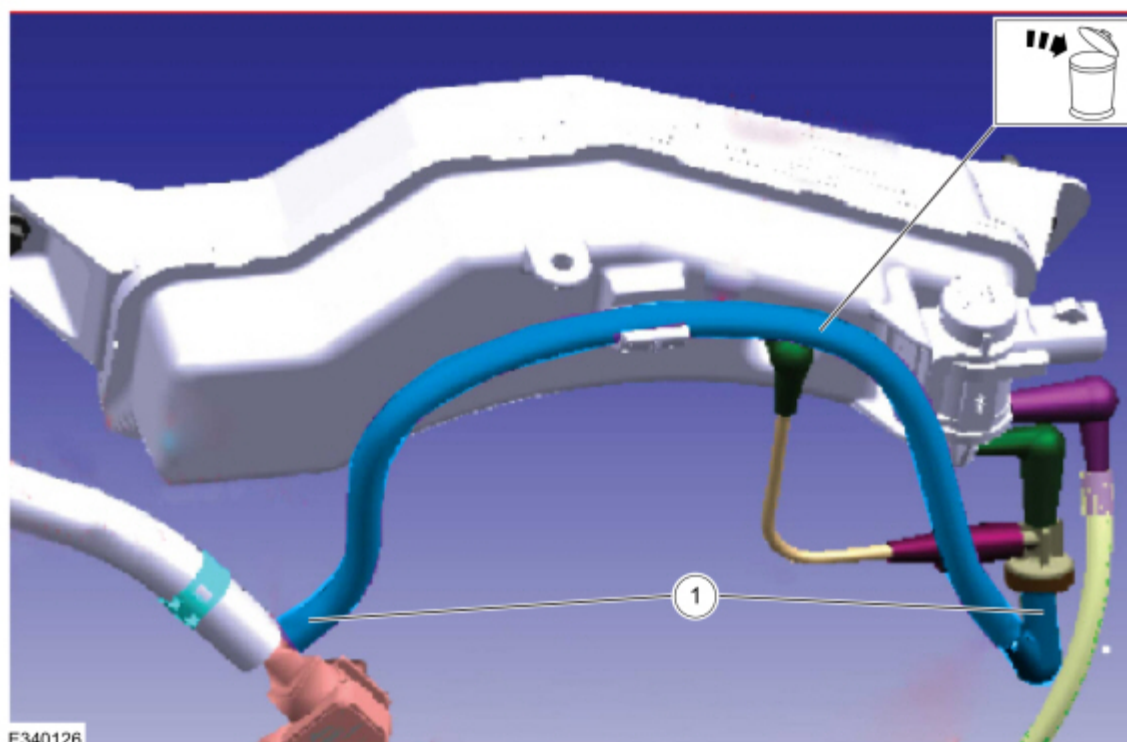
2. Locate the vacuum supply line between the source vacuum and the IWE check valve. Refer to WSM, Section 308-07A. (Figures 2-3)

**3.** Remove the vacuum supply line.

**4.** Install the vacuum caps at the IWE check valve and the vacuum source.
