# FEDERAL BUREAU OF INVESTIGATION

## Michigan State Police Sig Sauer M18 Evaluation

### TECHNICAL EVALUATION RESULTS

**30 AUGUST 2024**

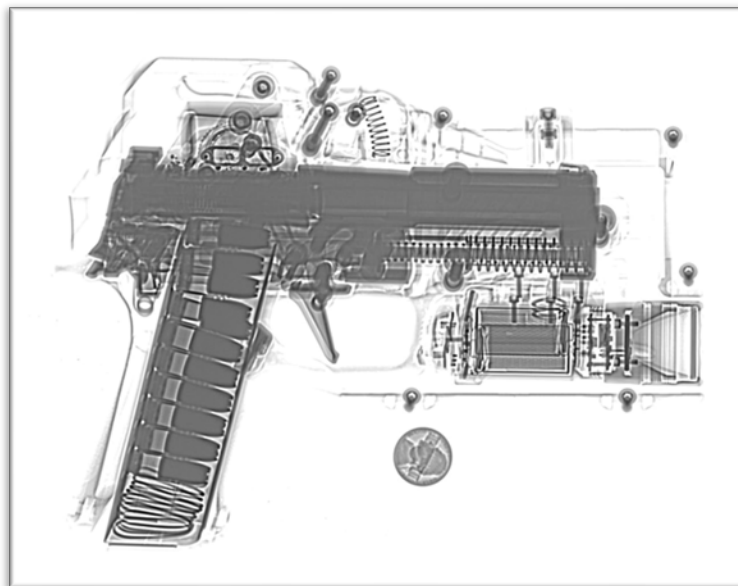
Figure 3- Initial X-Ray

Prior to any manipulation of the firearm or holster, x-rays were taken to determine the condition of the weapon and for any meaningful observations since the firearm had not been altered since the incident. There were no abnormal observations related to the firearm or signs of foreign objects in the holster as seen below<sup>10</sup>:

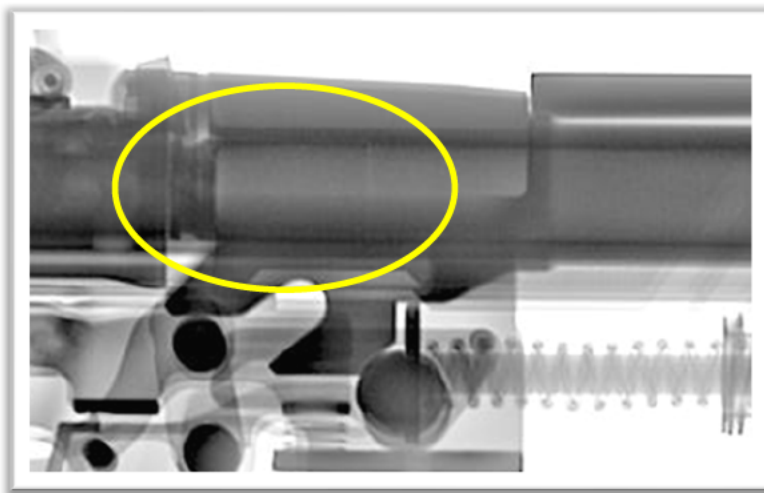
*Figure 6- Fired Case*

As visible in the additional x-rays, the firearm had one fired case in the chamber and had appeared to reset while in the holster as seen in the below images:

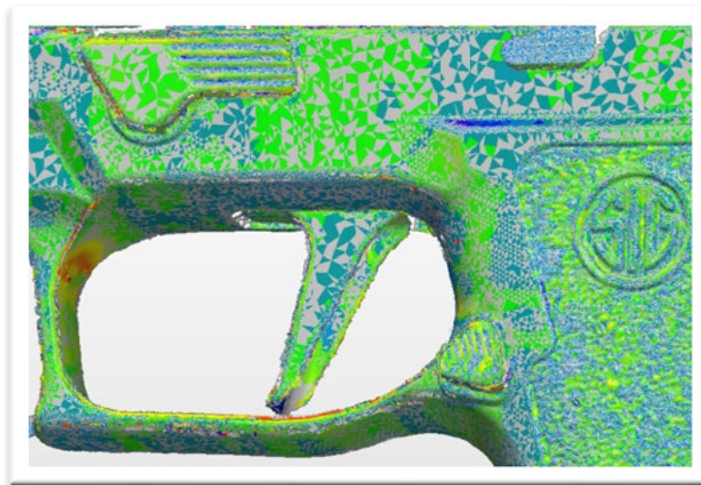
Figure 9 - Comparative Trigger Scan

The color variance from green to blue indicates between zero and 0.0025" change between the location of the trigger in the two scans. No significant change occurred indicating a full and proper reset of the trigger. If an abnormal condition was present in the firearm at the time of the uncommanded firing it was no longer observable following the complete reset of the trigger in the holster.

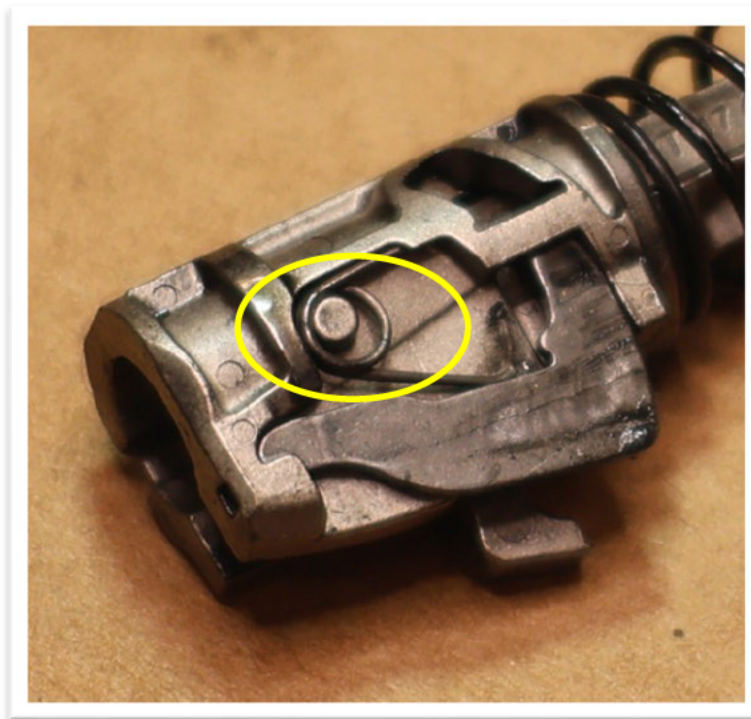
*Figure 10- Striker Safety Lock Spring Position*

The striker safety lock spring is used to hold the striker safety lock in a downward position until acted upon by the captive safety lever. The striker safety lock is intended to prevent the striker from moving forward in the event sear engagement (primary or secondary) is lost. It was observed that the spring was not fully seated on its post as seen in the below photograph:

It was also observed that the striker safety lock spring was only captured at the top of the striker housing. A pre-upgrade Sig Sauer P320 striker safety lock was reviewed for comparison, and it was observed that both the top and bottom of the striker safety lock spring was captured<sup>14</sup>. If the striker safety lock spring leg lost engagement with the top of the striker safety lock, the lock would no longer be spring loaded and could possibly seize or “free-float” rendering the striker safety lock inoperable.

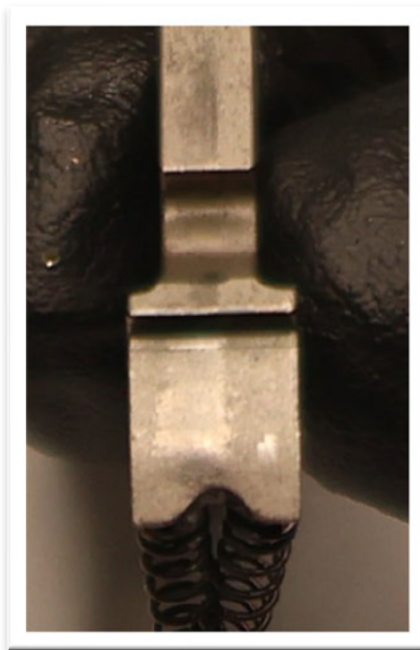
*Figure 11- Sear Wear*

Additionally, the wear on the sear appeared to be off-center and both the primary and secondary sear notch edges appeared worn as shown in the photograph below:

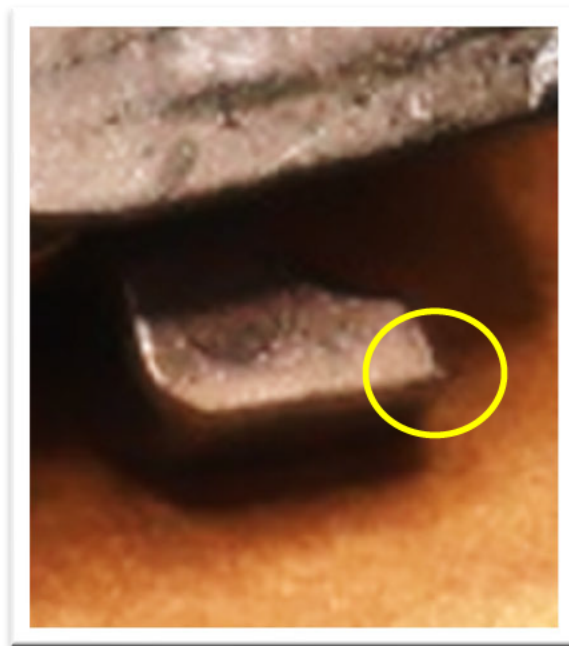
*Figure 12- Striker Pin "Ledge"*

The striker pin hook was examined due to its relationship to the sear during normal function. It was observed that the bottom of the striker pin hook face that engages with the sear had a "ledge" rather than being flat.

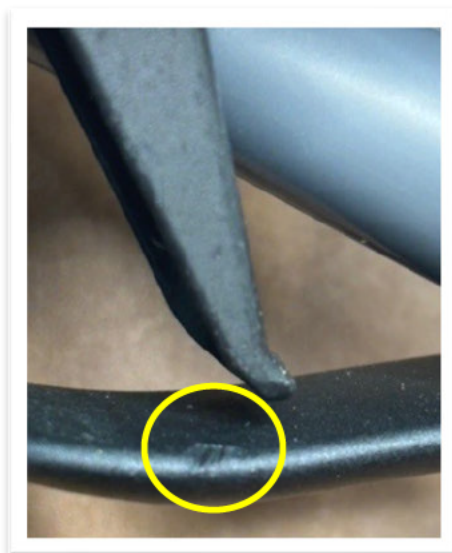
*Figure 13- Trigger Guard Abrasion*

Lastly, an abrasion was observed on the right-hand side of the weapon on the trigger guard as seen below:

It was reported by MSP that the motor officer's weapon impacted the ground during the transition program. However, it is unknown if this caused the abrasion.

BRF was successful in using keys, both flat and serrated profiles, to press the trigger while the M18 was holstered. The keys were approximately 1.7" and 1.0" respectively. The trigger could be fully pressed to the rear with sufficient pressure against the side of the trigger only, or by using the holster as a fulcrum. During this test it was observed that the keys caused an abrasion on the trigger guard near the area of the abrasion seen on the weapon when it arrived (Figure 13).

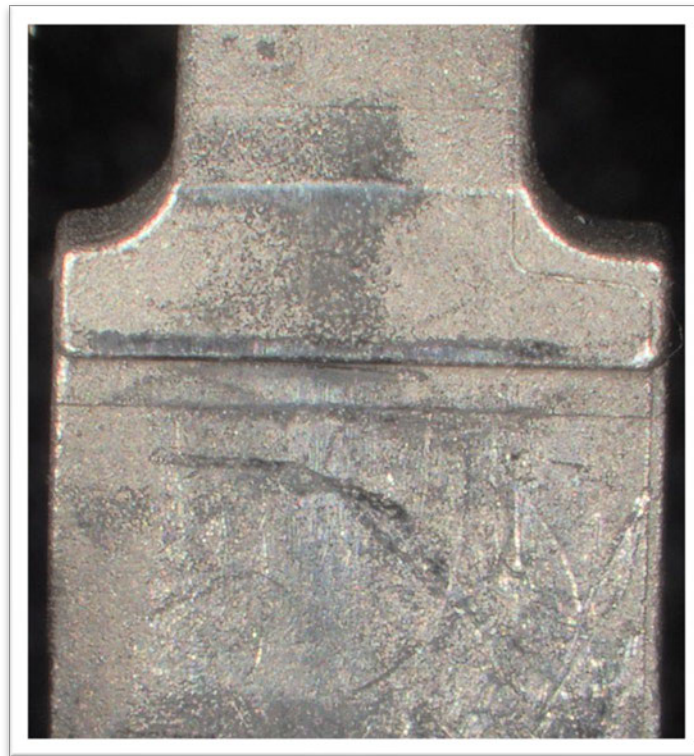
*Figure 16- Wear on the Primary Sear Notch<sup>18</sup>*

The primary and secondary sear notch edges exhibit wear aligned with the striker pin hook. The face edge of each sear notch has a "chipped" appearance. Additionally, there appears to be a manufacturing artifact on the primary sear ramp just in front of the primary sear notch.

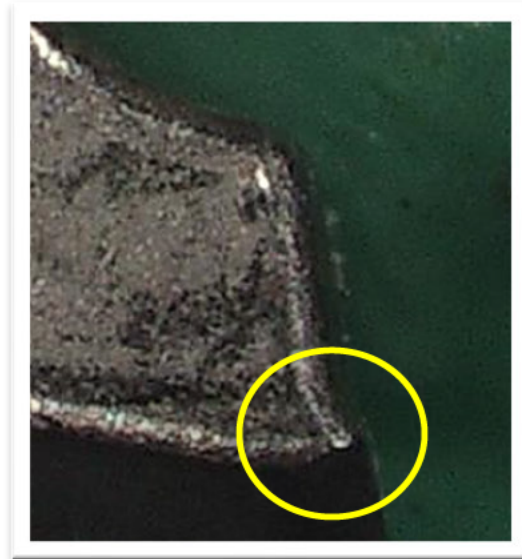
*Figure 18- Subject Firearm Striker Pin Hook "Ledge"*

The striker pin hook "ledge" shown in Figure 18 reduces the engagement surface between the primary sear notch and the striker pin face to the "face" of the "ledge". Additionally, the misshapen striker pin hook face may be contributing to excessive wear on the primary and secondary sear notches.

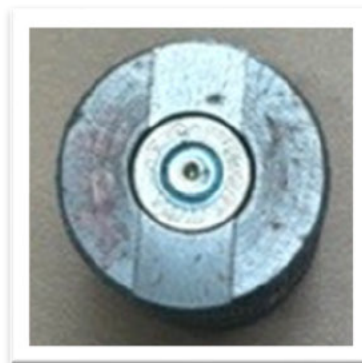
Figure 20- Spent Case

After the function test was completed and prior to the commencement of the parts inspection the fired case was extracted from the weapon. A digital linear gauge<sup>19</sup> was used to measure the striker indentation on the primer. The primer indentation measured 0.025"<sup>20</sup>.

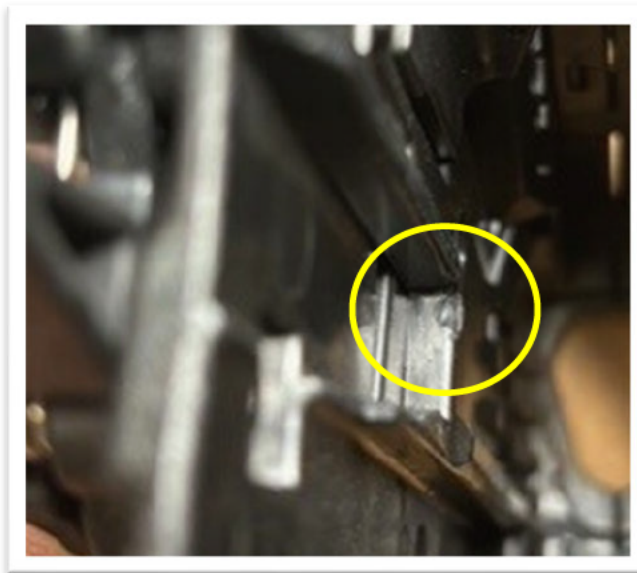
*Figure 21- Holster Wear*

The uncommanded discharge resulted in no observable damage to the holster. This is due to the open muzzle design of the holster which allows any debris which might fall into the holster to escape. The only observable wear was inside the holster and is a result of the takedown lever contacting a shelf inside the holster as seen below:

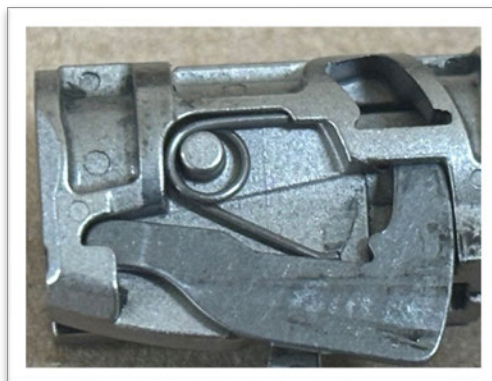
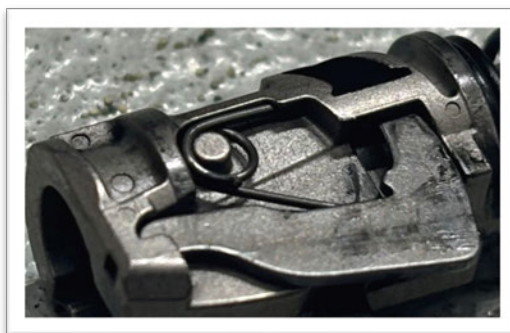
It was observed on all three iterations the striker safety lock spring moved during firing as seen in representative images below:

As previously stated, should the spring leg slip off the striker safety lock, it may leave the safety inoperable. So long as the space between the striker channel wall and the striker safety lock does not exceed the width of the striker safety lock spring, it should remain in place despite not being captured by design.

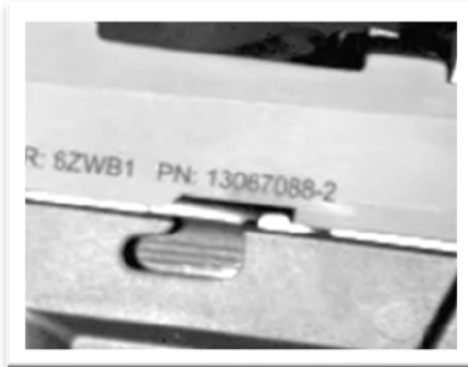
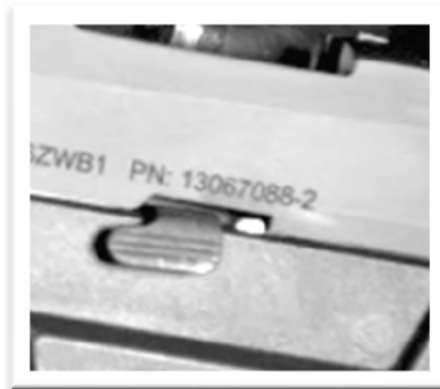
During recoil BRF observed the slide catch lever bounce into the slide catch notch. While no malfunctions were observed during this testing, [REDACTED]

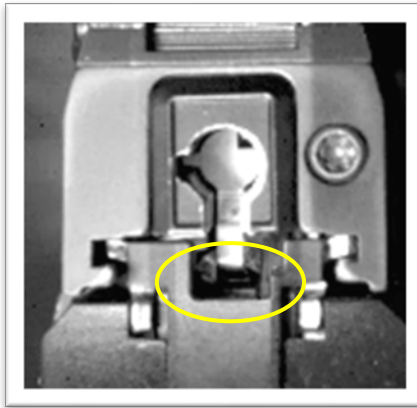
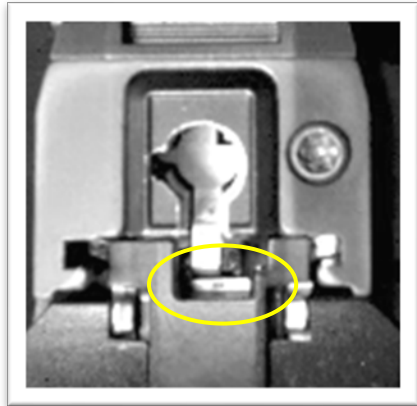
Both the sear and sear housing were observed to bounce during recoil. The sear bounced multiple times and impacted the striker pin and bottom of the slide several times during rearward slide travel. It is likely a combination of the forward striker pin movement and striker impacts during recoil that cause wear on the sear surfaces including the "chipping" of the sear face edges.

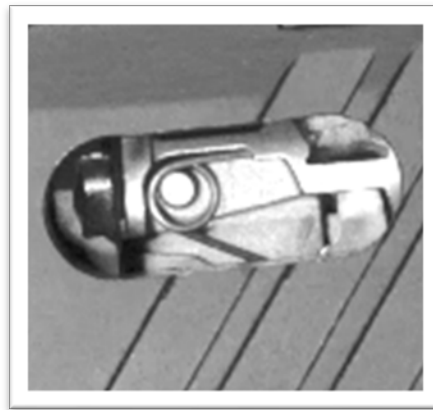
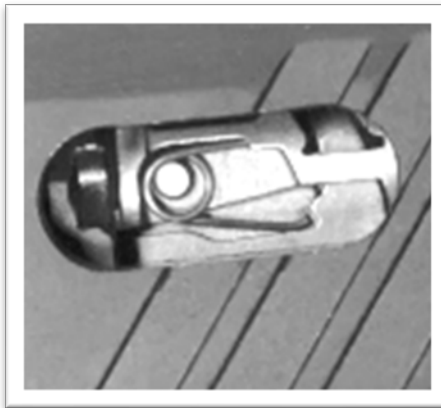
As previously mentioned, the striker safety lock spring is responsible for keeping downward pressure on the striker safety lock until the captive safety lever presses the striker safety lock upward allowing the striker to move forward enough to impact the primer. The spring is a single coil, two-leg design and as previously stated only captured at the top leg location. During recoil the movement of the striker safety lock and spring were observed and there were no obvious abnormalities.

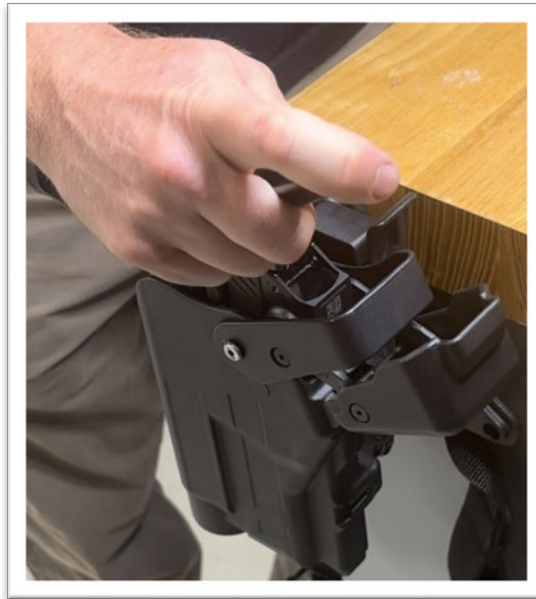
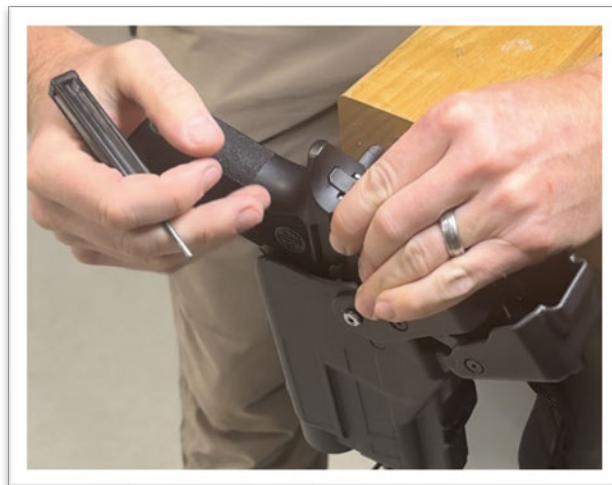
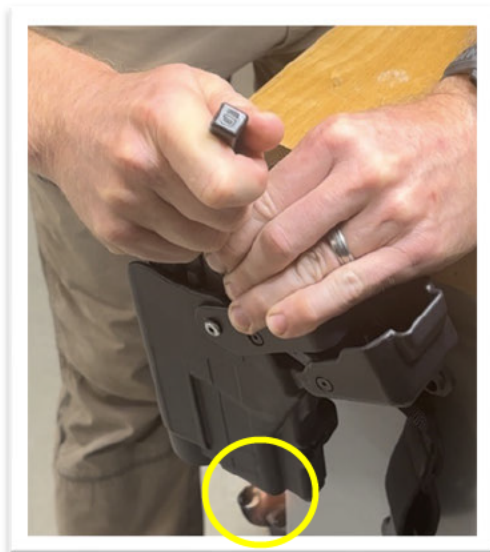
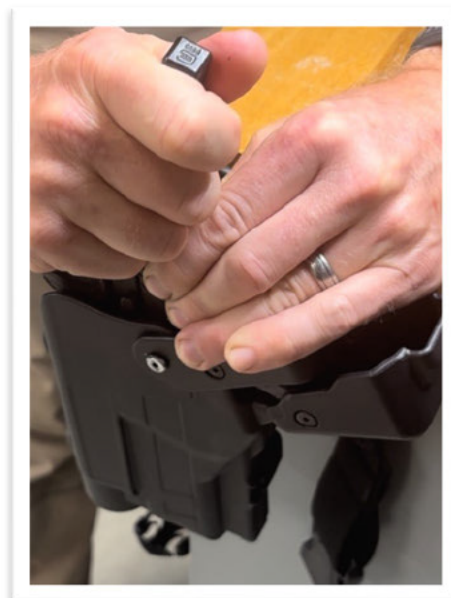
BRF staff observed the primed case fired on nine attempts with the primer indent measuring between 0.019"-0.026" with an average of 0.023". While staging one attempt to allow another BRF staff member to observe the striker safety lock function as designed, the weapon was prepared and placed into the holster with no manipulation. A second staff member released the primary sear notch from the striker and the primed case fired indicating failure of the striker safety lock. The primer indentation measured 0.018".

attempt the primed case fired, indicating the striker safety lock failed to stop the striker's forward movement. The primer indent measured 0.023".
