# FEDERAL BUREAU OF INVESTIGATION

## Michigan State Police Sig Sauer M18 Evaluation

### TECHNICAL EVALUATION RESULTS

**30 AUGUST 2024**

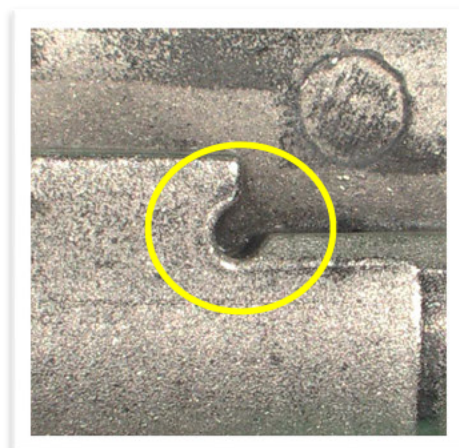
*Figure 14- Striker Safety Lock Notch*

It was also observed that the striker safety lock spring was only captured at the top of the striker housing. A pre-upgrade Sig Sauer P320 striker safety lock was reviewed for comparison, and it was observed that both the top and bottom of the striker safety lock spring was captured<sup>14</sup>. If the striker safety lock spring leg lost engagement with the top of the striker safety lock, the lock would no longer be spring loaded and could possibly seize or “free-float” rendering the striker safety lock inoperable.

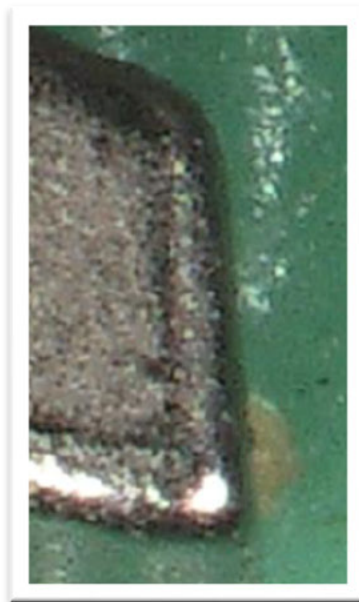
*Figure 19- Reference Striker Pin Hook for Comparison*

The striker pin hook "ledge" shown in Figure 18 reduces the engagement surface between the primary sear notch and the striker pin face to the "face" of the "ledge". Additionally, the misshapen striker pin hook face may be contributing to excessive wear on the primary and secondary sear notches.

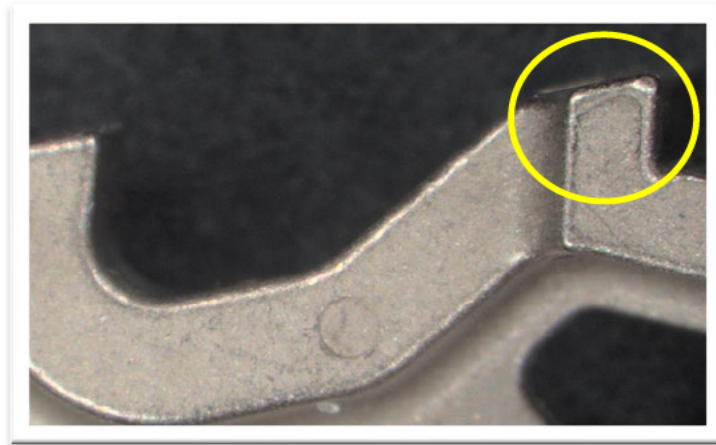
*Figure 31 - Pre-milled Sear*

To test the secondary sear notch, milling of the primary sear notch was necessary. In order to avoid altering the fire control unit (FCU) of the subject firearm, a spare FCU was utilized<sup>27</sup>. The objective was to provide enough engagement between the striker pin hook and the primary sear notch that connection would not be lost until intentionally induced. The inherent issue with changing the primary sear engagement is the change in timing of the secondary sear notch to "catch" the striker pin hook.

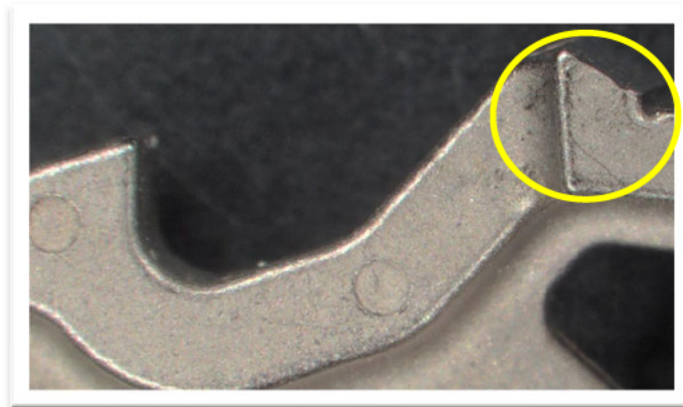
*Figure 32 - Post-milled Sear*

Milling the primary sear notch<sup>28</sup> resulted in less vertical distance the secondary sear notch had to travel (thereby increasing the possibility it catches the striker) but it also reduced the spacing between the last point of primary sear contact and the secondary sear notch face (reducing the possibility it catches the striker). As such, the result of this supplemental test is limited to the modified test firearm and should not be applied to the subject weapon. However, the test does provide insight into the design and function of Sig Sauer's added safety feature.

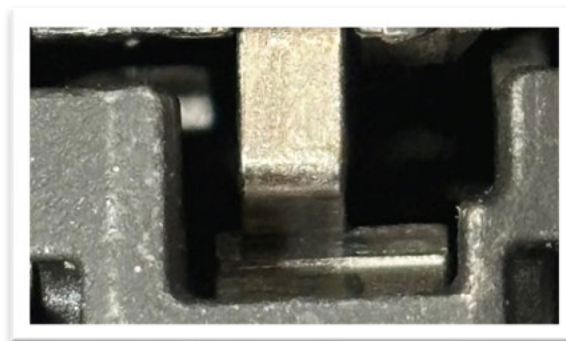
*Figure 33 - Striker Hook Placement on Primary Notch*

BRF conducted ten tests of the secondary sear in which the striker pin hook was placed on the 45-degree cut primary notch and released the striker by tapping the holstered firearm with a dead blow mallet<sup>29</sup>. The secondary sear successfully caught the striker pin hook on all ten attempts.
